Dartbrook
Underground Mine

ANNUAL REVIEW 2018

HANSEN BAILEY
127-129 John Street
SINGLETON NSW 2330

March 2019

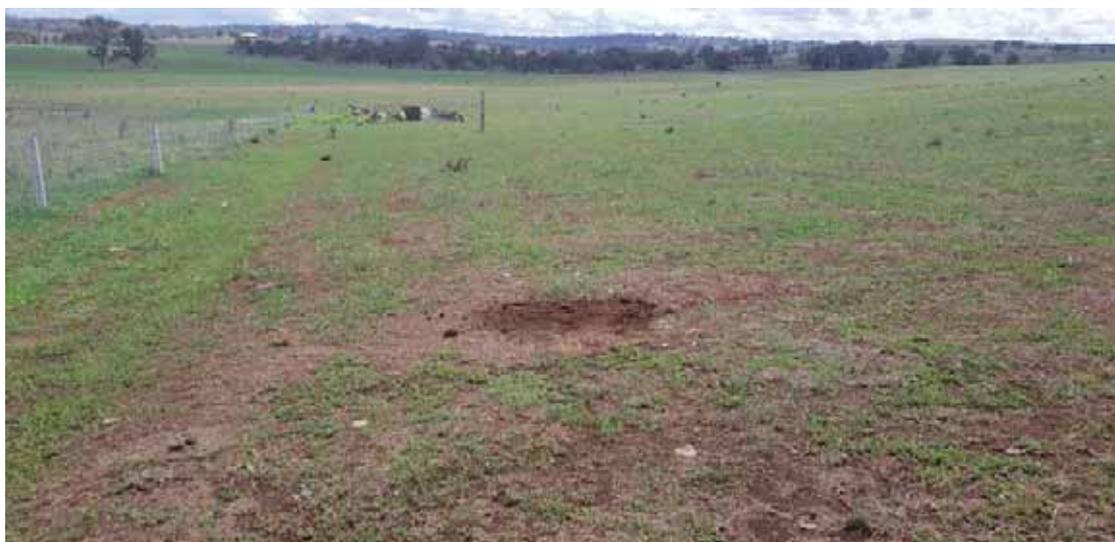
Plate 1
Rehabilitated Historic Borehole Site RDH168

Following a 2014 Independent Environmental Audit (IEA) by SLR on the condition of existing exploration boreholes, 26 historic open boreholes were identified as requiring rehabilitation. Rehabilitation of these boreholes was completed in October 2018 as part of the exploration program following consultation and approval from DRG (see **Plate 1**). Of the 26 holes, 19 were rehabilitated, three were unable to be located in the field (sites RDH093, RDH153 and RDH154) and four sites (sites RDH156-159 and DDH023) on private land were not available for rehabilitation, following discussions with the relevant landholder/s.

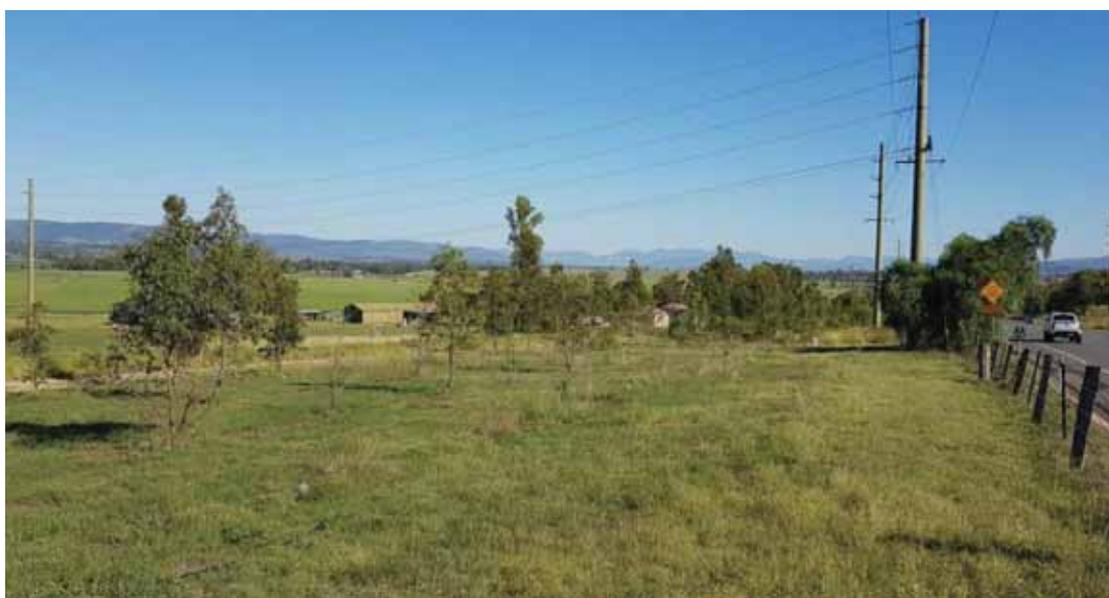
Plate 2
Tree Screening adjacent to New England Highway 2018

A 75-ha forestry plantation was established north of the CHPP in 2003 and is detailed further in **Section 8.4**. This plantation was surveyed in 2018 and was found to be progressing well, with Spotted Gum dominating. As the trees continue to mature, they will provide additional screening of the township of Aberdeen from views of the CHPP.

Maintenance of the tree screening areas will continue as required subject to the prevailing weather conditions. A review of the screens will be undertaken during the next reporting period and replacement trees established if significant mortality of plantings occurs.

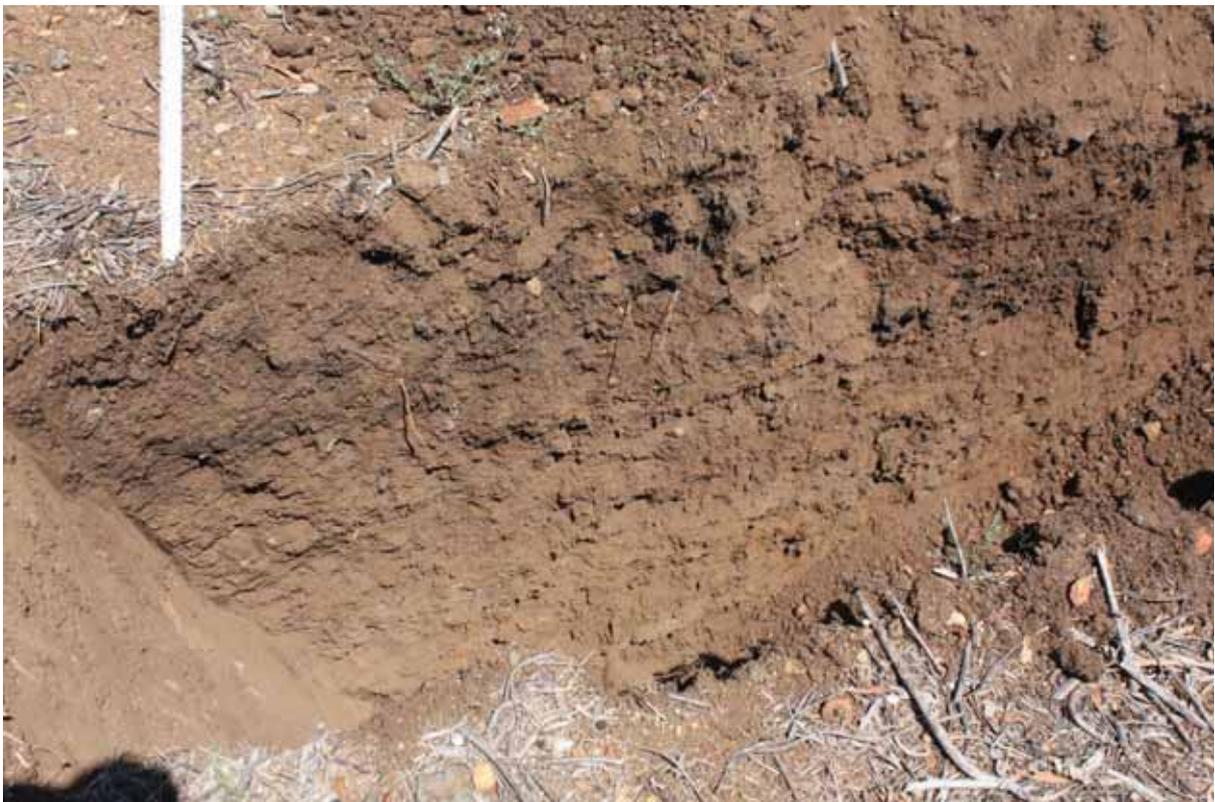
Photo No.2. East Site excavation shows layering of stockpiled material (test pit ET1)
